Kent County Council Flood Risk Management Committee

November 2014

Agenda

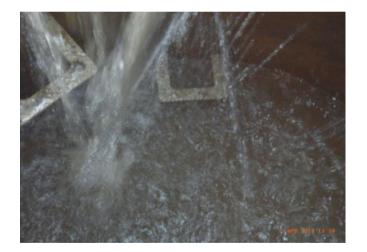
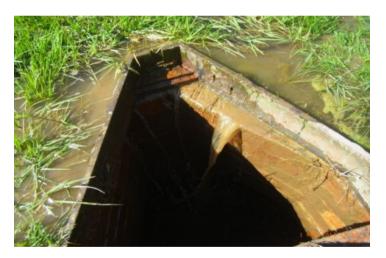
- Managed surcharged sewers by tankers
- Undertaken raising/sealing/replacement covers for 8 manholes

Plans to replace tankers with temporary pumped discharge directly to Ottinge Pumping Station

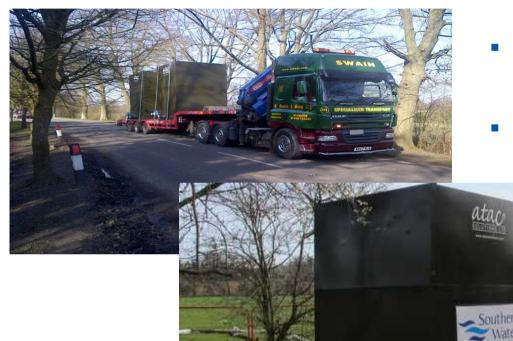
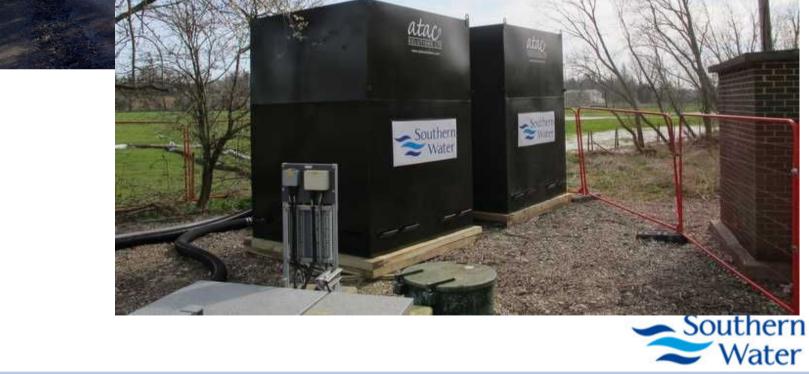
Bio-treatment units

- Developed in-house
- First of their kind in the Country
- Improves the quality of the discharge

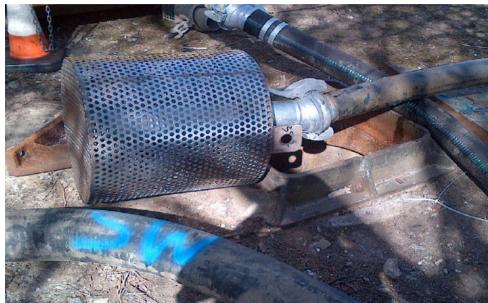
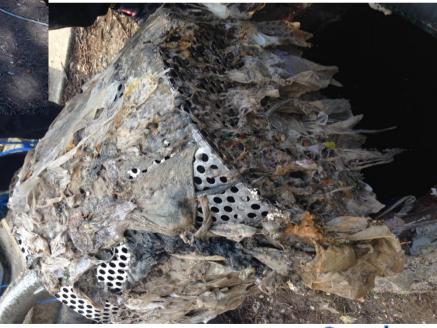
Suction Screening

Improves the quality of the discharge and prevents pump blockage

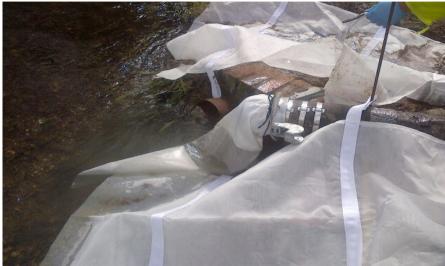
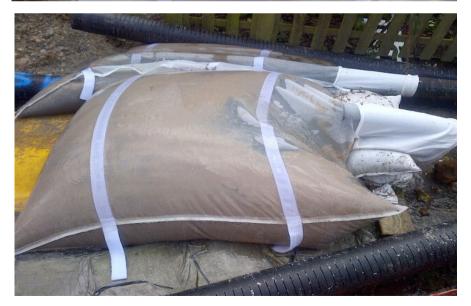
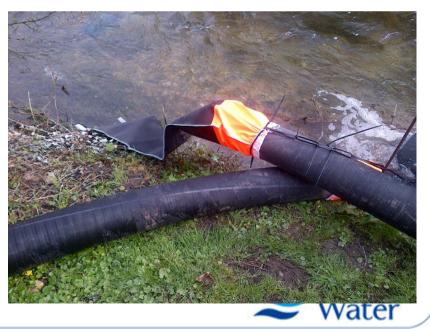
Effluent Screening

Improves the quality of the discharge by fine screening

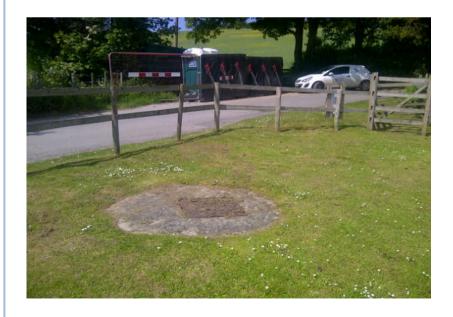
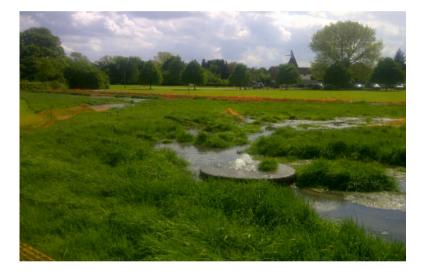
Petham Bourne

- Flooding from manholes in the grounds of the Stiener School
- First occasion since 2000/01
- Water ingress and reliability/capacity of pumping station believed to be the cause

- 8 manholes, repaired, sealed or water tight covers fitted
- Pumping station refurbished, pumps replaced with modern day equivalent, threefold increase in capacity
