Project Name
A28 Sturry Link Road, Canterbury

Drawing Title
**FIGURE 3
A28 Island Road /
A291 Sturry Hill
Junction Improvement**

Drawing No
4300392/000/72

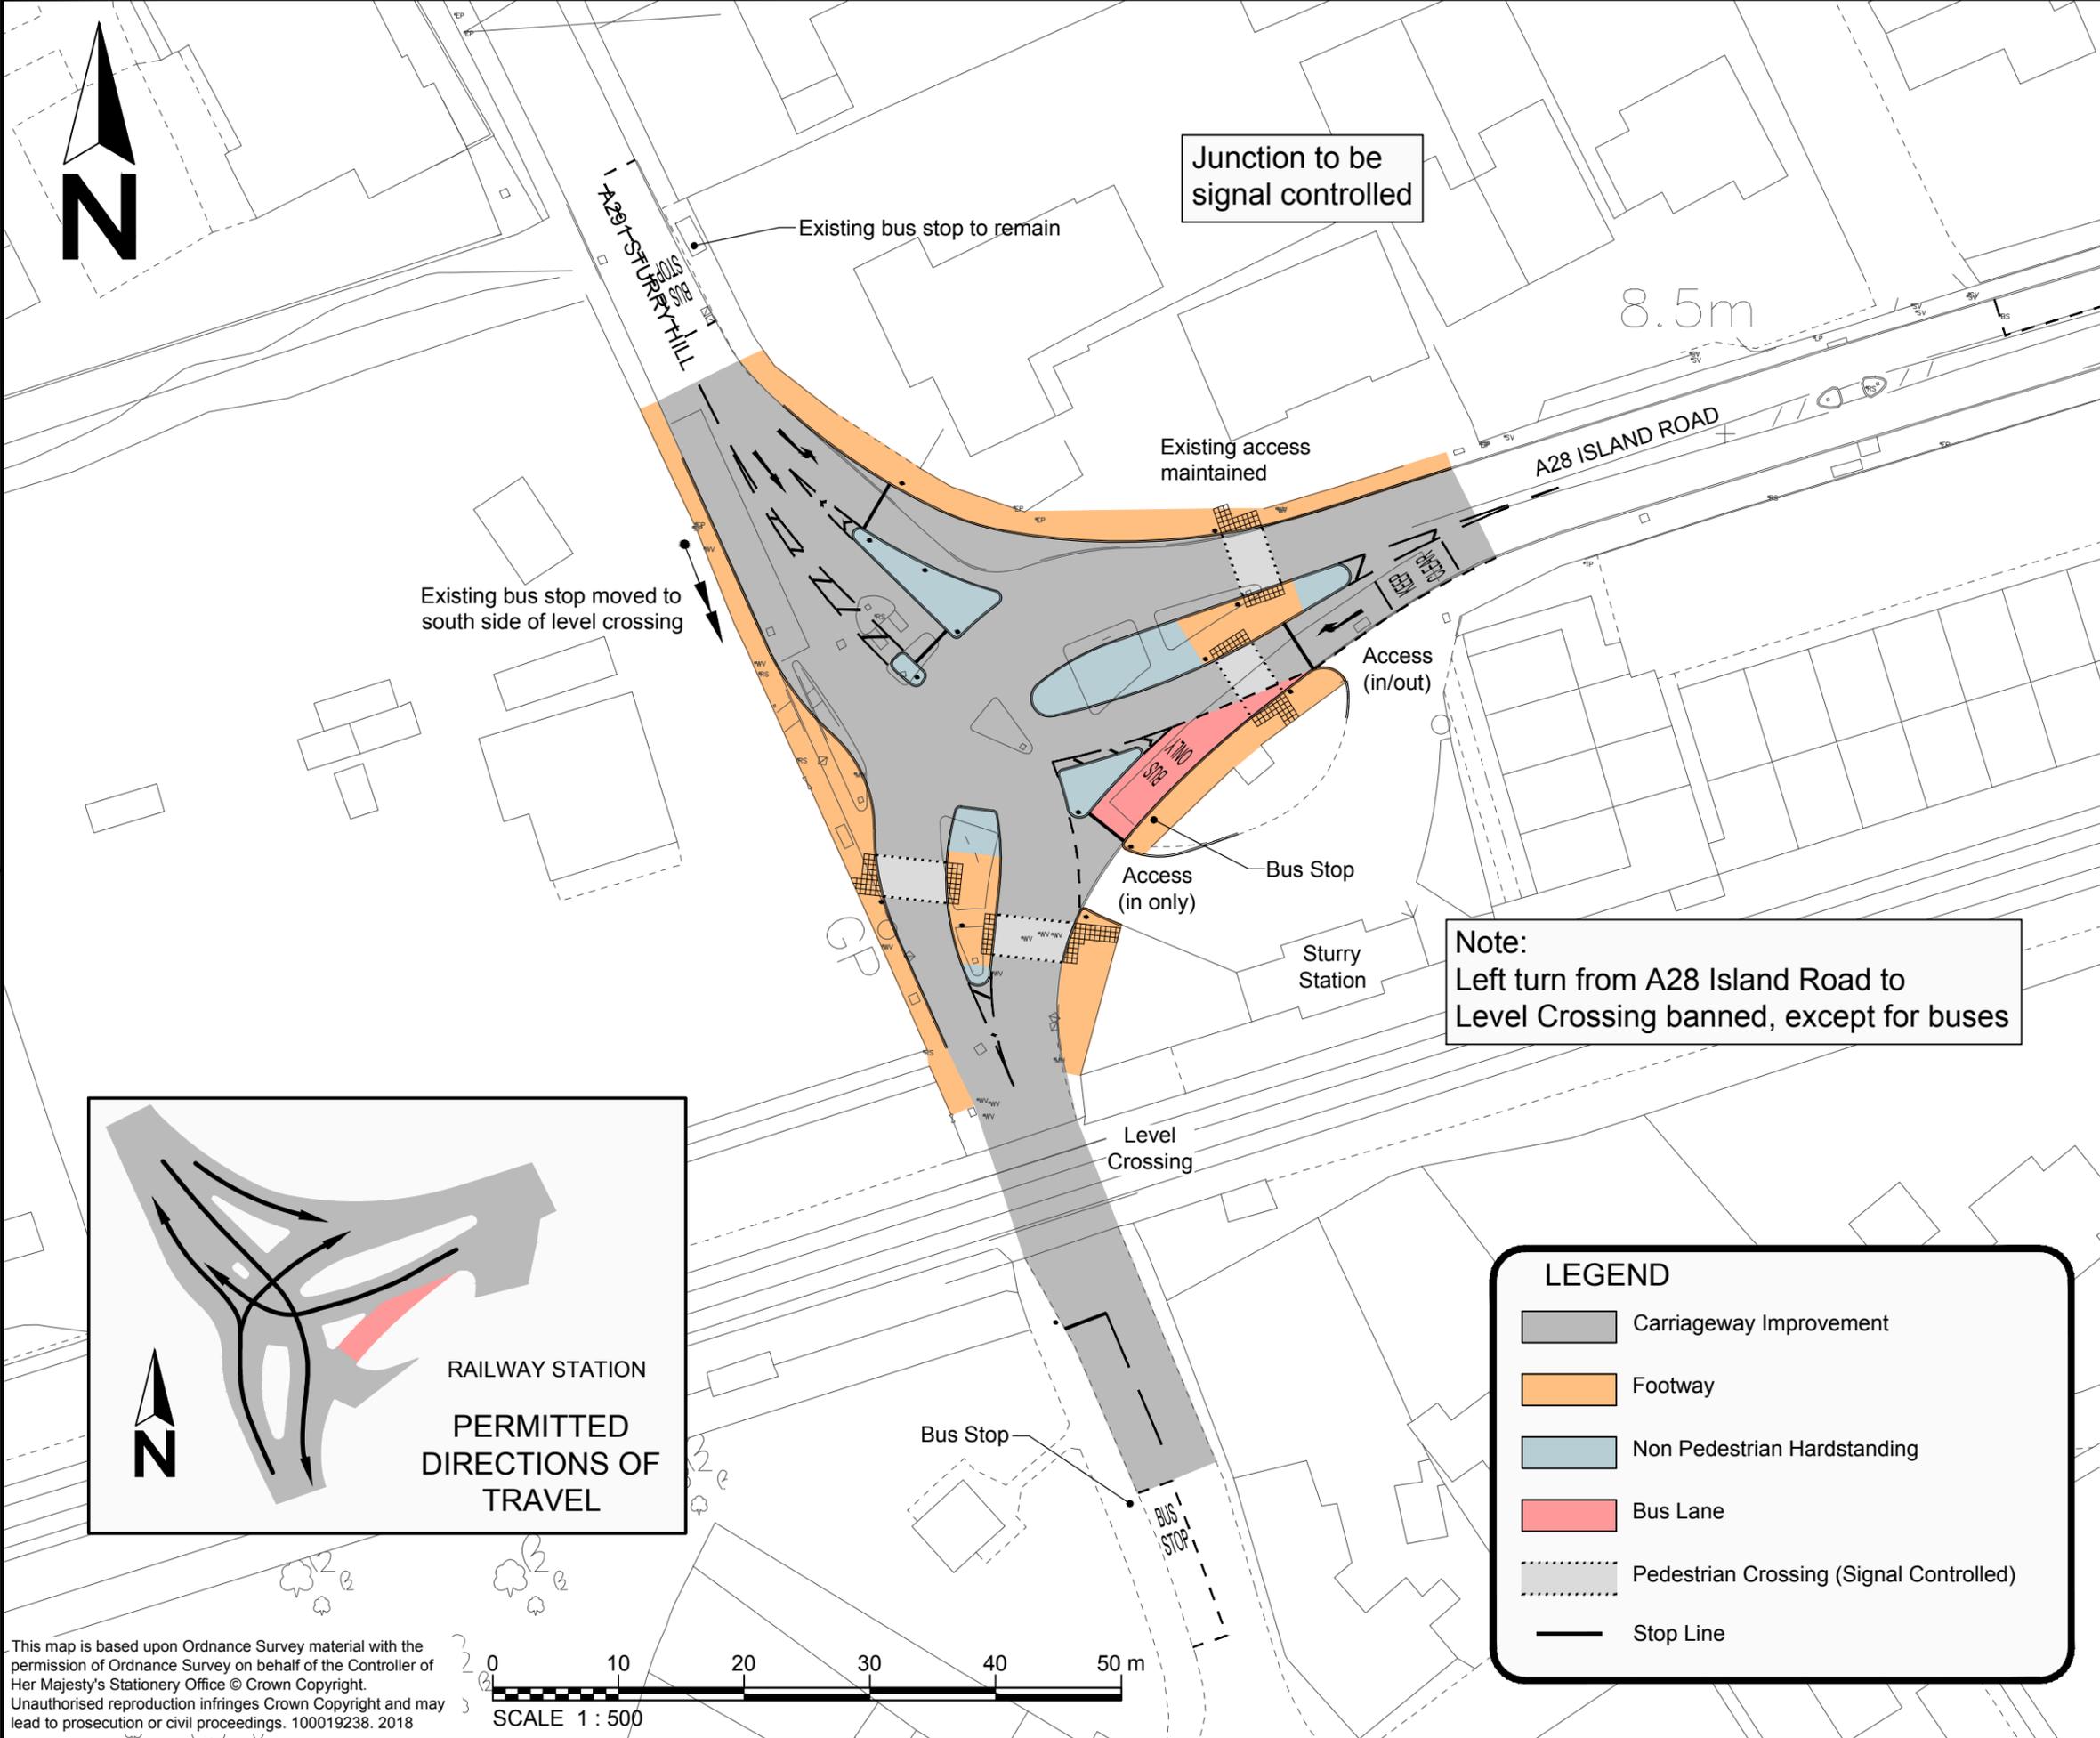
Existing bus stop moved to south side of level crossing

Junction to be signal controlled

Existing bus stop to remain

Existing access maintained

Note:
Left turn from A28 Island Road to Level Crossing banned, except for buses
